REPAIR REQUEST EXAMPLE

JOIST DAMAGE

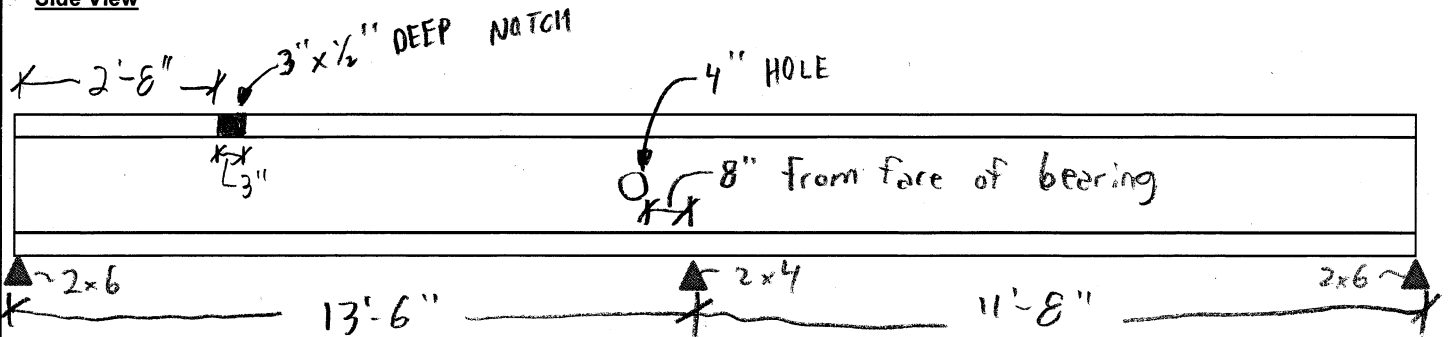
Side View

FLANGE NOTCHED AS SHOWN
 HOLE IN JOIST TOO CLOSE TO BEARING

TJI® JOIST SERIES: 110 210 230 360 560
 JOIST DEPTH: 9 1/2" 11 7/8" 14" 16" 18"
 JOIST SPACING: 12" 16" 19.2" 24"
 APPLICATION: FLOOR ROOF
 LIVE LOAD (PSF): 40 DEAD LOAD (PSF): 15 (HARD WOOD)
 ADDITIONAL LOAD: N/A
 # OF DAMAGED JOISTS: 1
